PREDL SYSTEMS
 7520 Conrad Street
 Burnaby, BC V5A 2H7

Project: Load testing on PVC manhole (as named by client) -Reference standard- ASTM D3753-12, Clause 6.4.1

1.0 INTRODUCTION

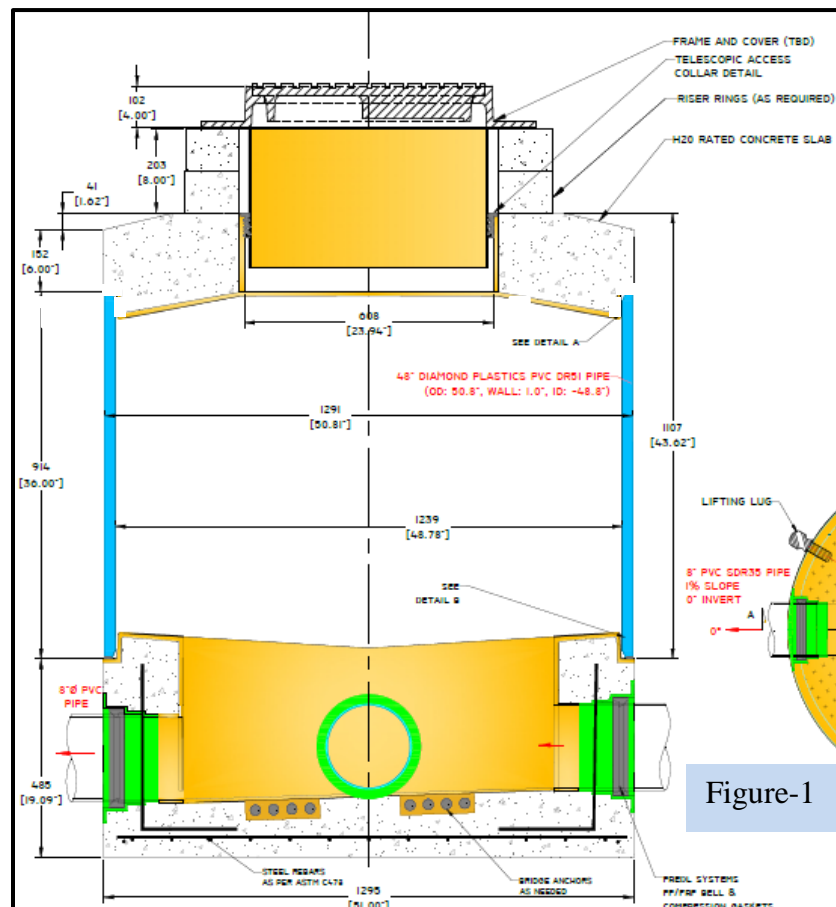
Figure-1

Client confirmed that this PVC manhole used for testing is manufactured with the similar consistency as the actual service manholes. It was concentric type of manhole (as shown in figure.1).

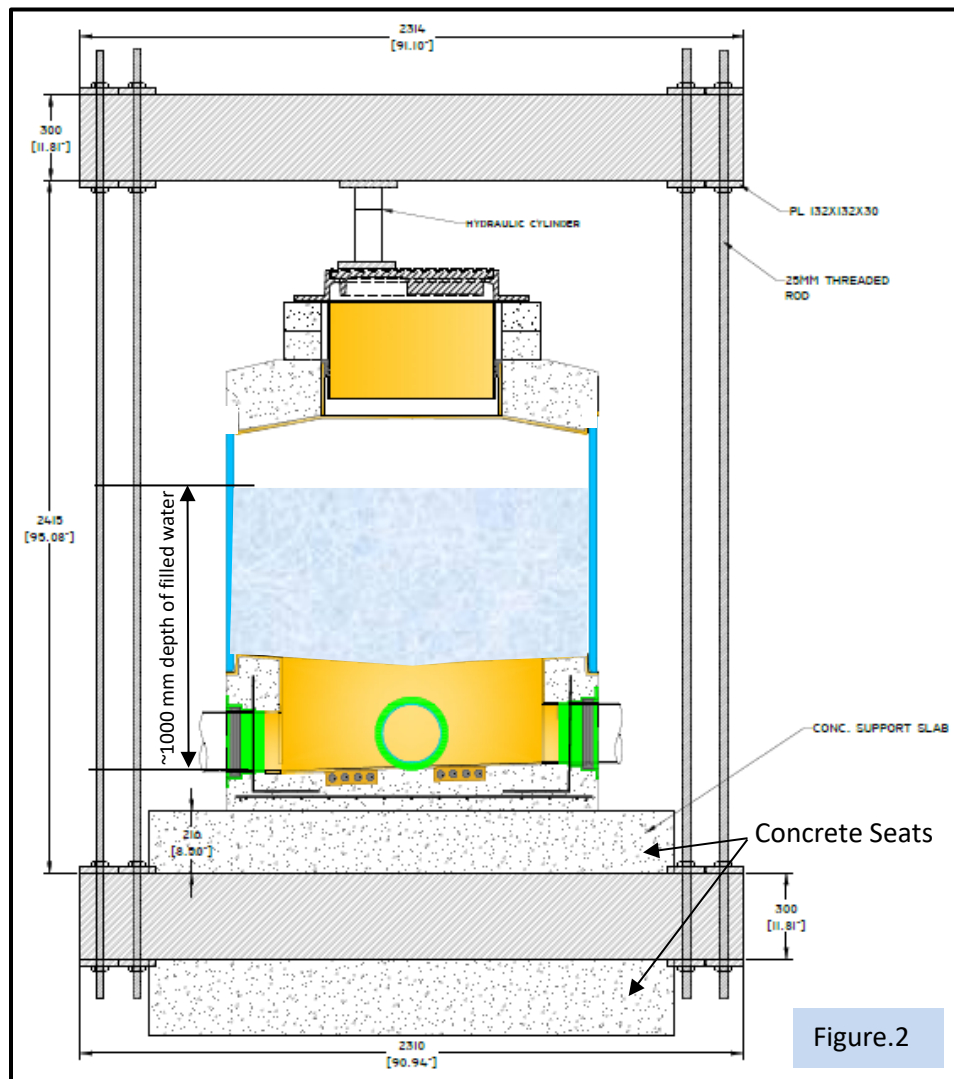
Figure.2

- Metro applied the loads using the prefabricated steel bridges. The test load was applied eccentrically (See figure.2)

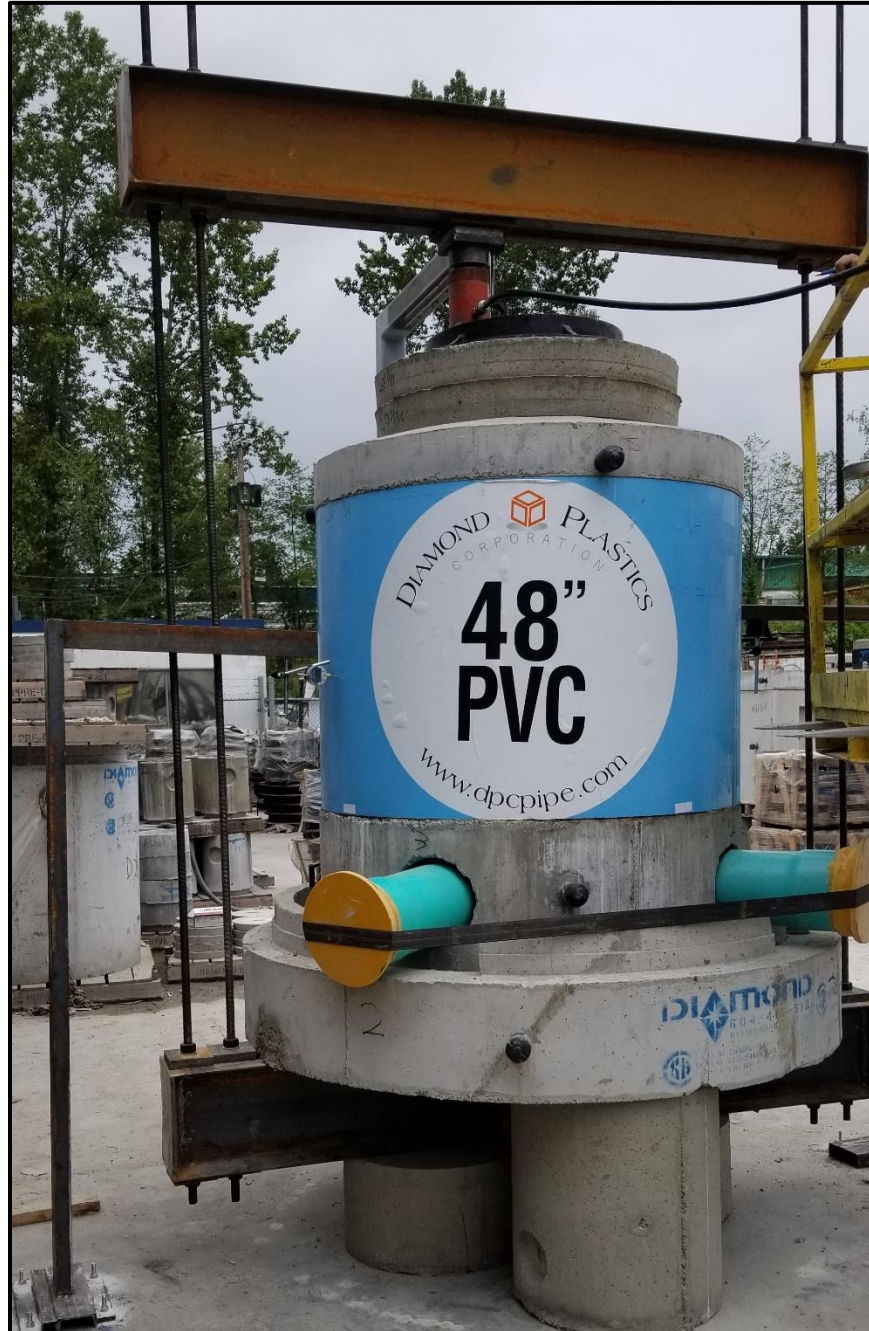
Pic.1: Manhole Test Assembly

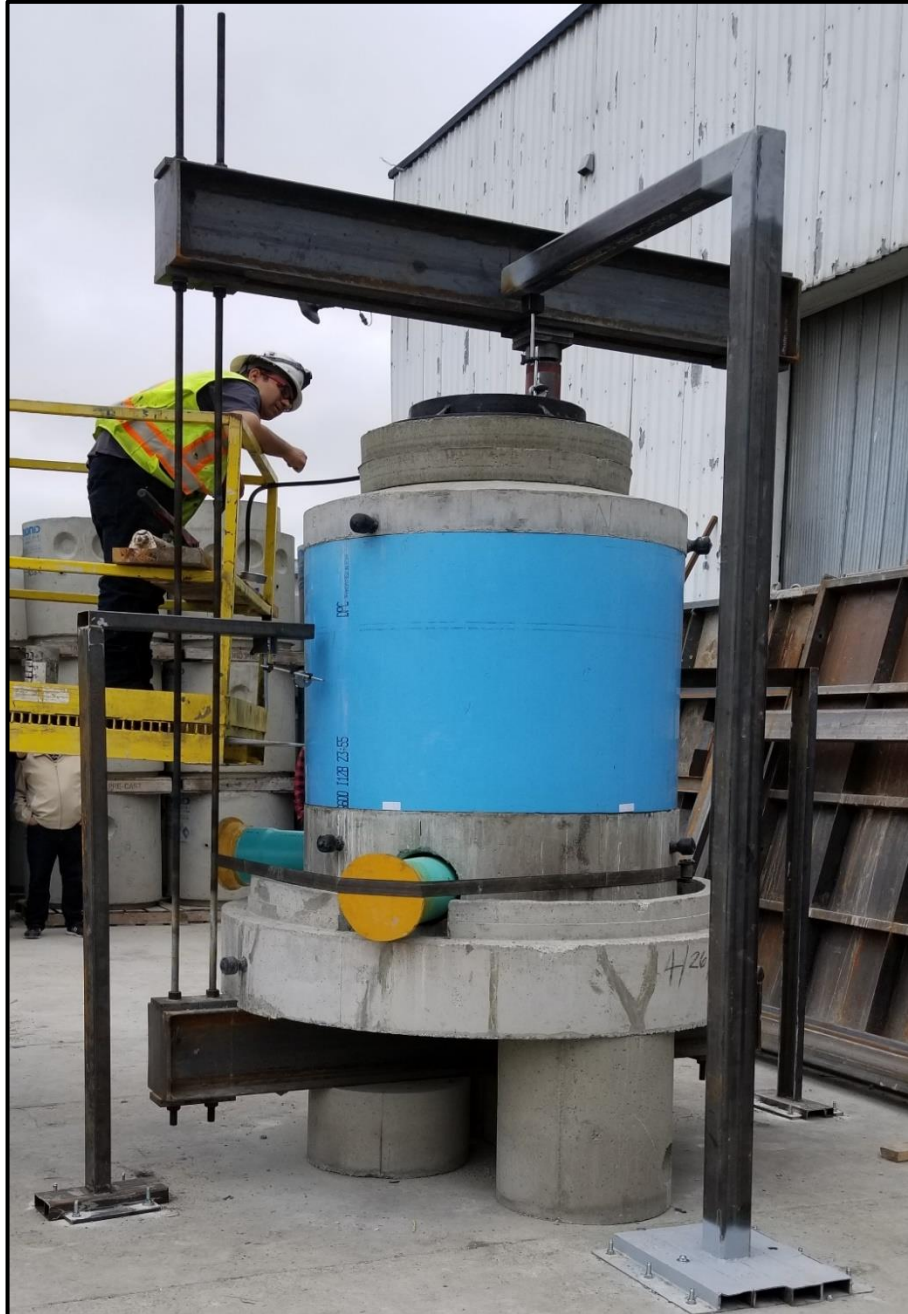
Pic.2: Testing in progress

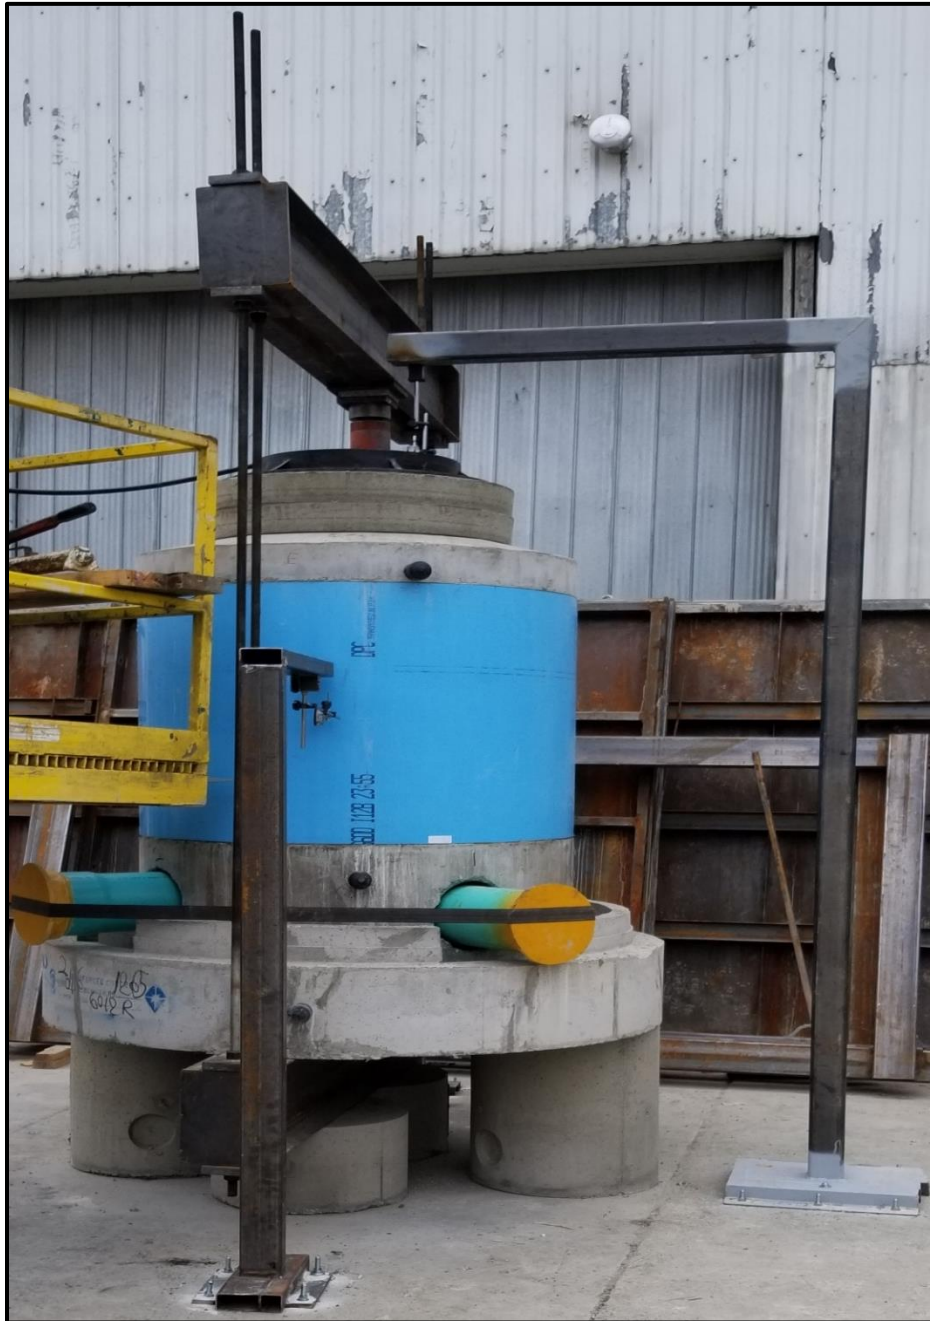
- Gauges were installed on separate standalone arms which were bolted in concrete floor.
- Metro used 30 Ton Ram and 10,000 PSI gauge to perform testing. Calibration sheet is attached in appendix.

Pic.3: Bridge assembly and standalone arms for Gauges

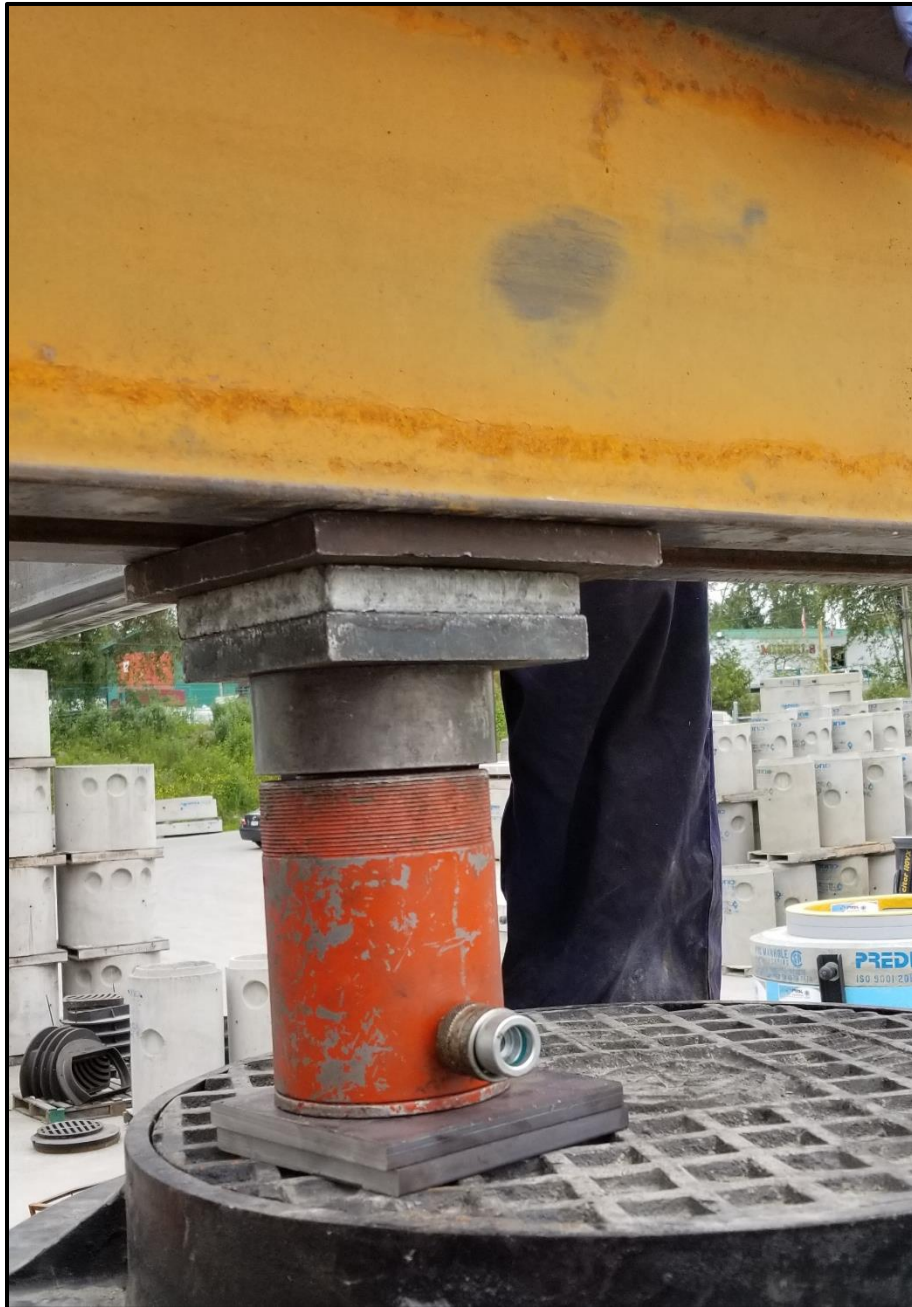
Pic.5: Hydraulic ram set up

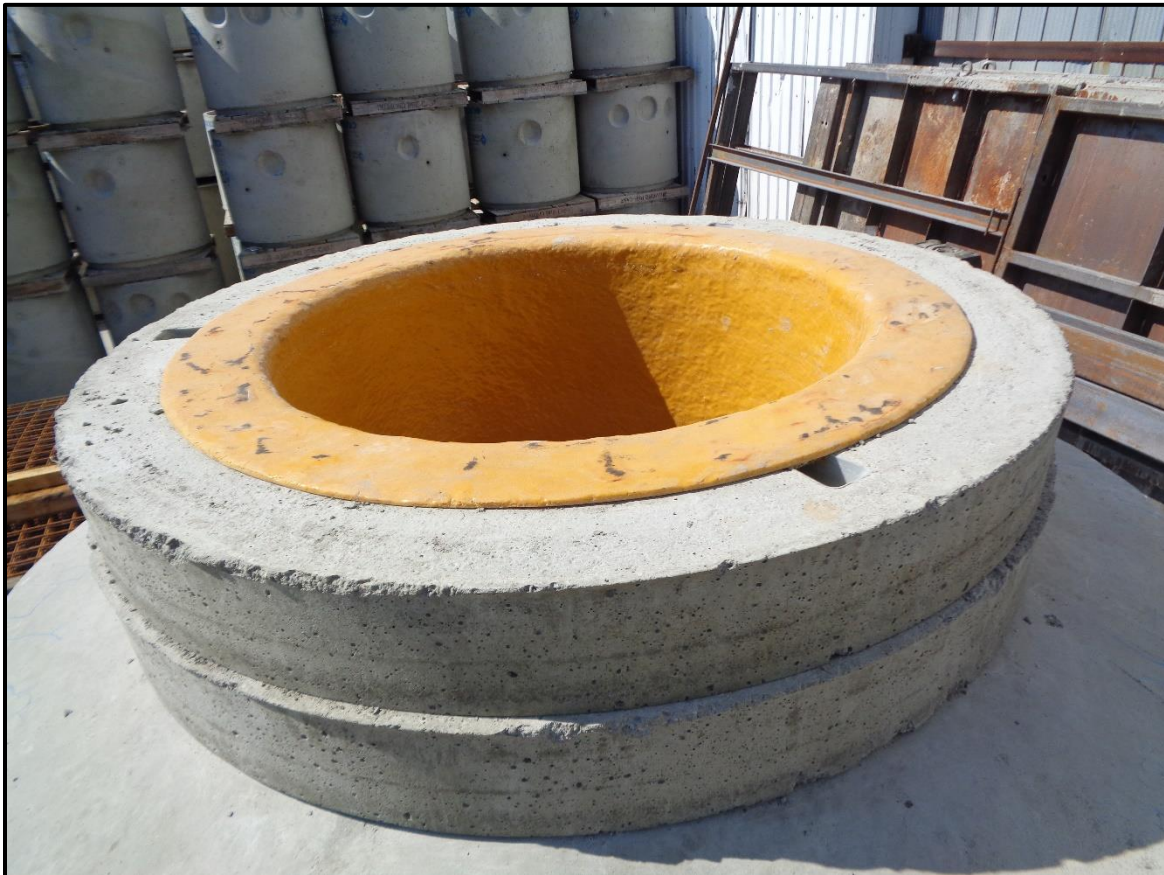
Metro closely reviewed different parts of the manhole such as the fiber glass collar under the concrete rings to detect any potential damage.

Pic.6: Local contact marks on the fiber glass collar under the concrete rings, does not indicate any signs of the failure

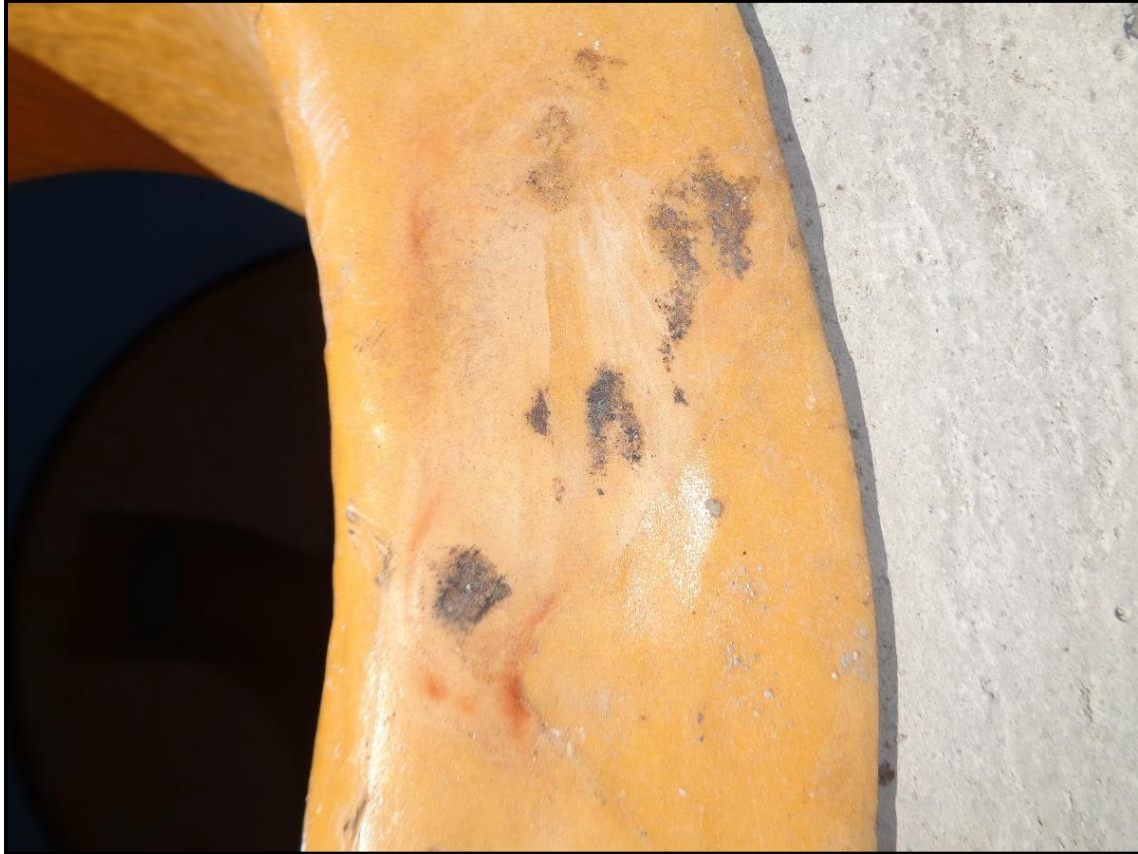
Pic.7 Local contact marks on the fiber glass collar under the concrete rings, does not indicate any signs of the failure the concrete rings

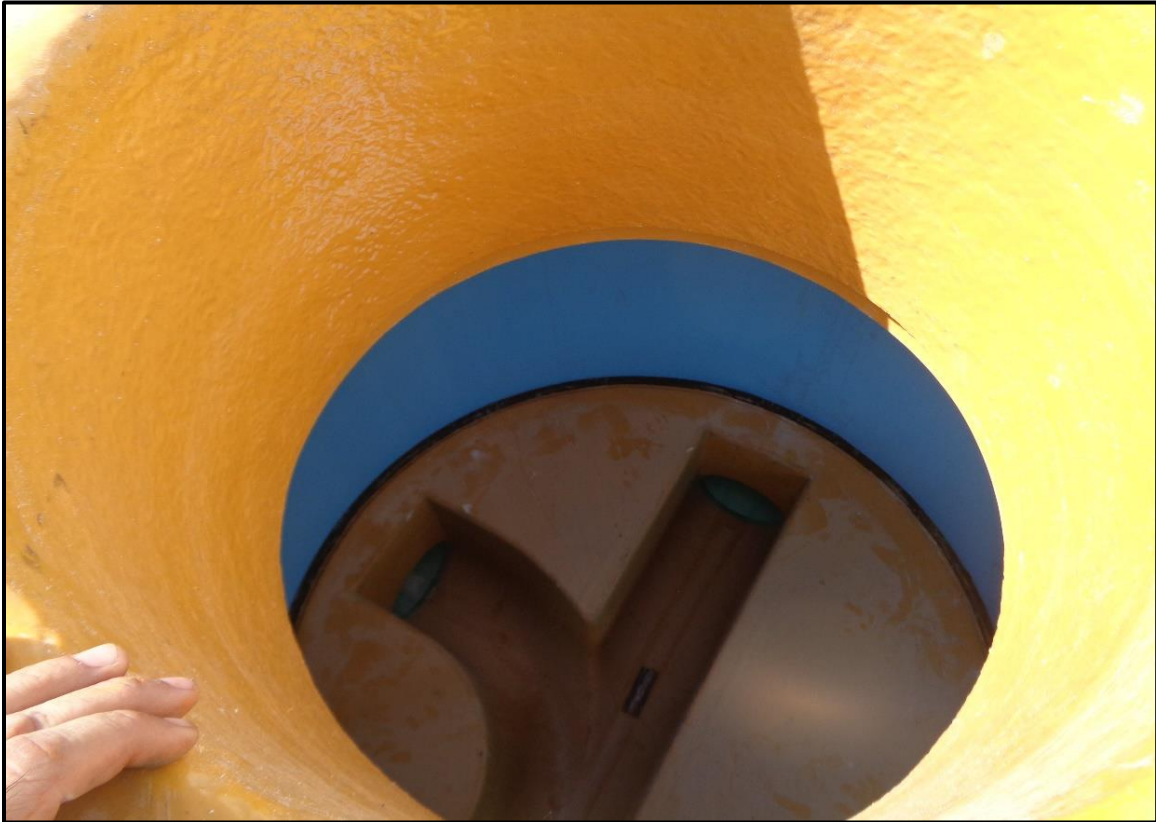
- The recorded vertical deflection at 24000 lbf was 0.085 in. (2.17 mm), which is below than the allowable deflection value of 0.25 in. (6.35 mm) as per clause 6.4.1 of ASTM D3753-12.
- After maintaining the 40,000 lbf load for 15 minutes as per clause 6.4.1 of ASTM D3753-12, Metro did not observe water any leakage, new cracks or damages in the manhole structure.

Pic.8: Inside view of manhole after testing

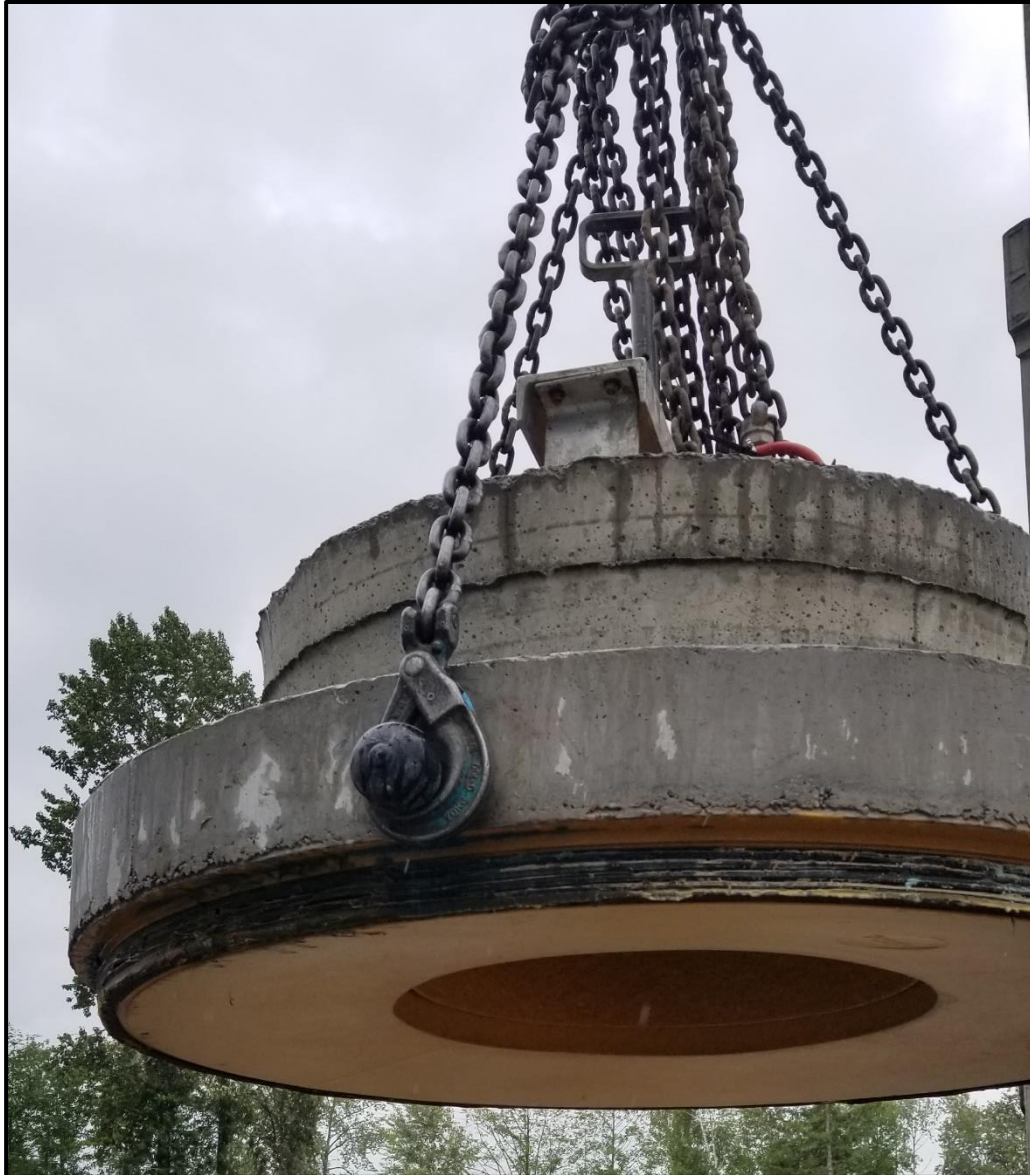
- Gaskets were installed at the top and bottom vertical interfaces of PVC pipe and concrete pieces. One layer of the mastic was observed at the bottom horizontal interface of the PVC pipe and concrete base (pressed thickness of the mastic was 1-2 mm).

Client informed Metro that Hamilton Kent, Tylox Type “C” gasket, Model 5796 as an ASTM C443ASTM compliant Manhole Riser gasket, was used.

Pic.9: Gasket on vertical interface of concrete and PVC pipe

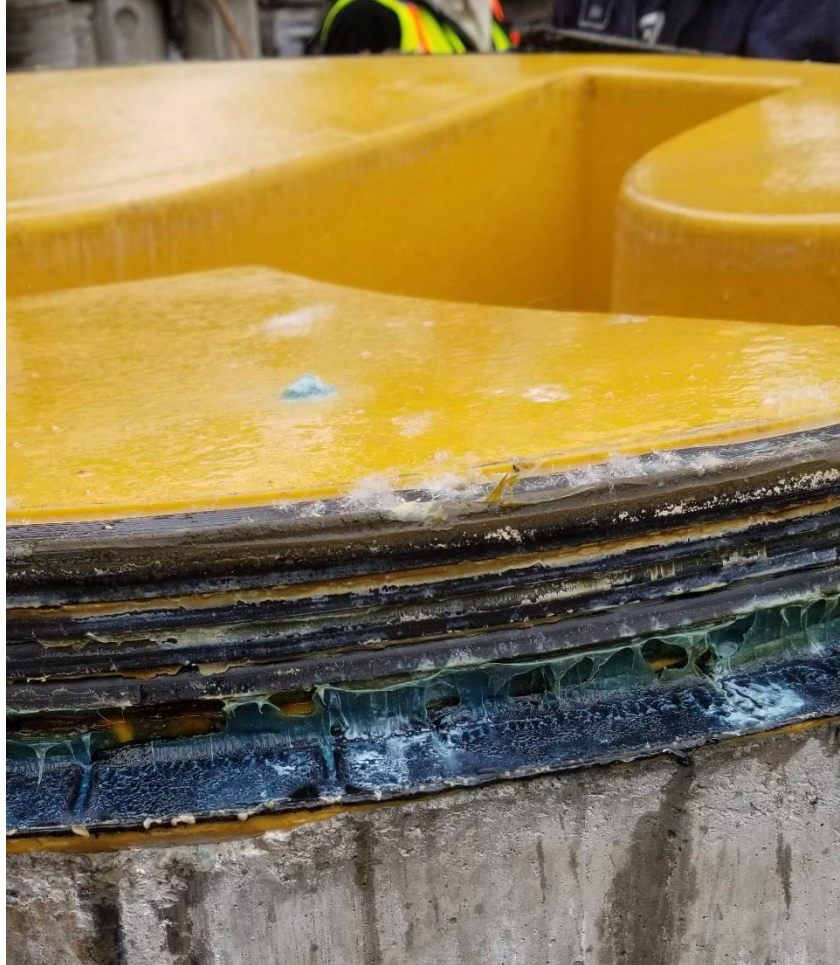
ConSeal, CS-102 Butyl Rubber Sealant (called mastic in this report) was used in the manhole assembly. As per the materials technical data sheet, the mastic is an ASTM C990-compliant Butyl Mastic Sealant.

Pic.10: Gasket on vertical interface of concrete and PVC pipe and Mastic on Horizontal surface of concrete
